3.3. AREA II

3.3.1. Yongsan Garrison

3.3.1.2. Overview of findings

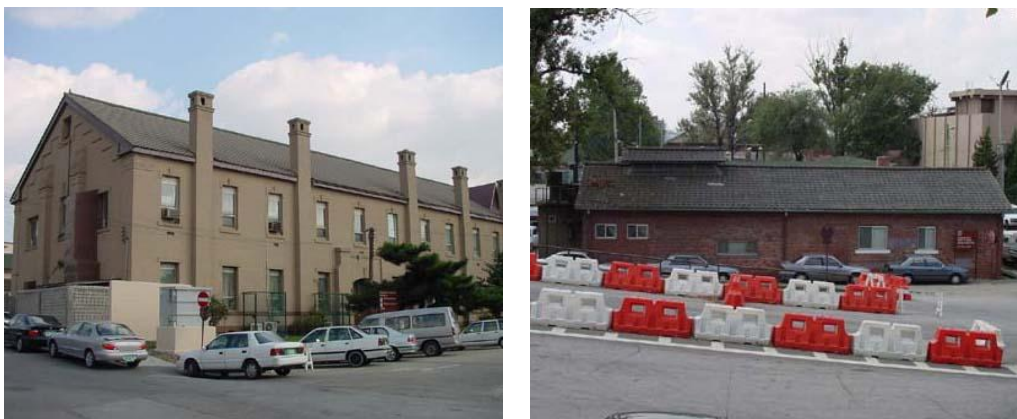
Figure 3.56. Well-preserved building 2254 (IB-063) and 2566 (IB-081)

Each building displays unique architectural style. Building 2254 (IB-063) is beautifully decorated with chimneys and dormer windows while building 2566 (IB-081) has ventilation slits between two-layered roofs (figure 3.56).

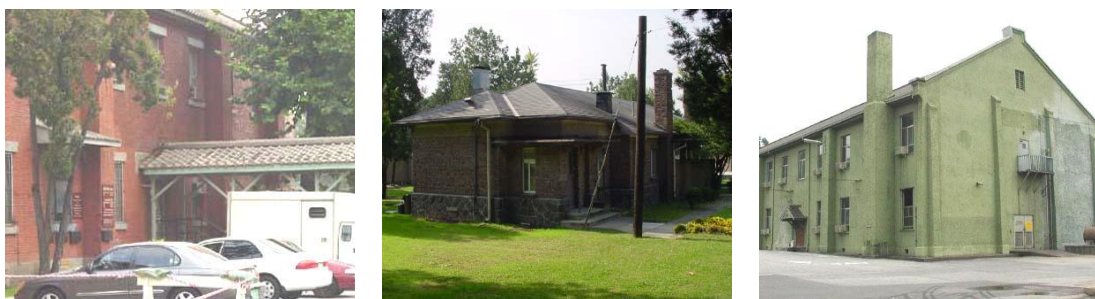
Figure 3.57. Well-preserved building 2640 (IB-062), 4150 (IB-161) and 5735 (IB-189)

Window frames of building 2640 (IB-062) are decorated with stones. Building 4150 (IB-161) was used as a high official's residence. Building 5735 (IB-189) can be regarded as the most important indigenous building located in the South Post because of its magnitude and well preserved exterior (figure 3.57).

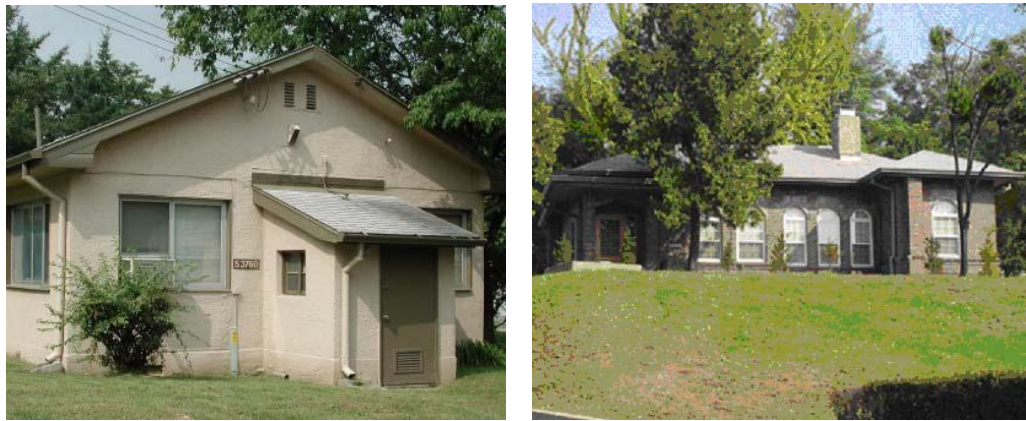
Figure 3.58. Building 3760 (IB-103) and 4456 (IB-150) used as officials' residence

Good examples of Japanese military officer's residence identified from Yongsan Garrison are building 2742 (IB-066), 2750 (IB-068), 2758 (IB-069), 2760 (IB-075), 2768 (IB-078), 2776 (IB-080), 2780 (IB-087), 3734 (IB-123), 3744 (IB-116), 3746 (IB-113), 3748 (IB-111), 3752 (IB-109), 3760 (IB-103), 3766 (IB-102), 3770 (IB-093), 3774 (IB-094), 3780 (IB-212), 4150 (IB-161), 4331 (IB-107), 4358 (IB-118) and 4456 (IB-150).

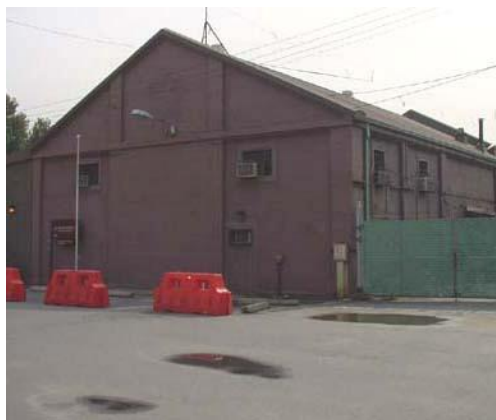
Figure 3.59. Building 1260 (IB-029) used as a storage facility

Storage: Building 1260 (IB-029) is a unique Japanese storage building constructed in 1910s to 1920s.

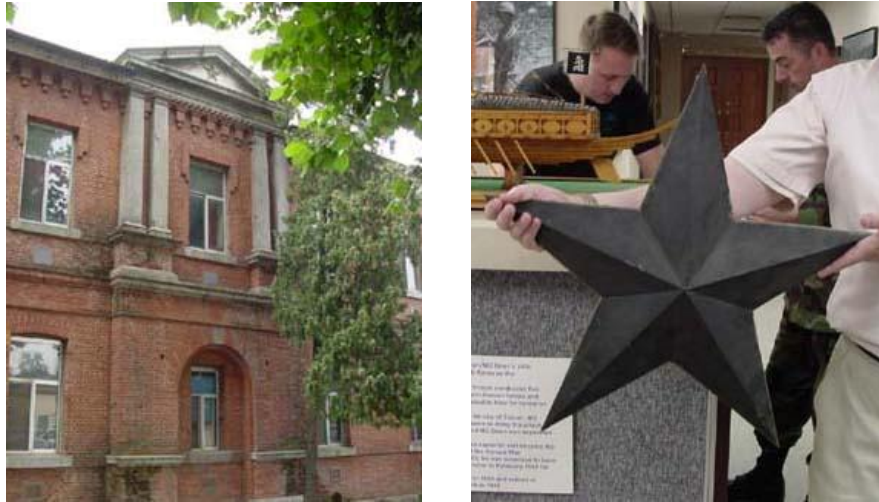
Figure 3.60. Building 2364 (IB-074), with artistic details of pillars and gables and building's star decoration currently located in the War History Office

Artistic structures: Building 2364 (IB-074) was used by the Japanese Infantry Regiment. Though the annex structure has been demolished, the main building is remaining intact with its beautiful pillars and gables. A star figure, originally attached on the building wall, is currently located in the War History Office.

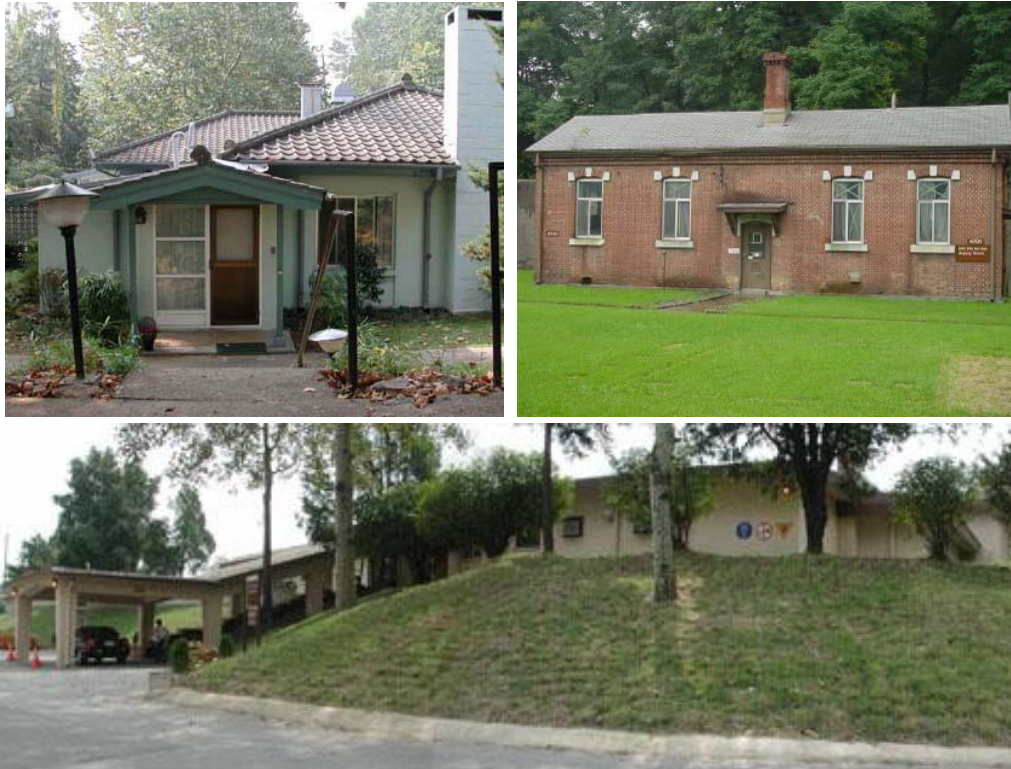
Figure 3.61. Building 1378 (IB-029), 4701 (IB-117) and 4763 (IB-166) from left top

Building 1378 (IB-048), 4701 (IB-117) and 4763 (IB-166) have beautiful details. Layers of roofs of building 1378 and window frame details of building 4701 are good examples of architecturally delicate designs. The Front stairs of building 4763 are constructed along the slope of a mound as shown in the figure 3.61.

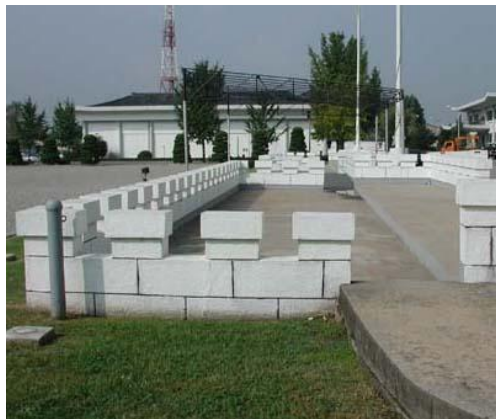
Figure 3.62. Building 2324 (IB-056) in front of building 2310

Building 2324 (IB-056) seems to be a podium with surrounding shallow wall. The shape of the wall is similar to typical Korean castle walls (figure 3.62).

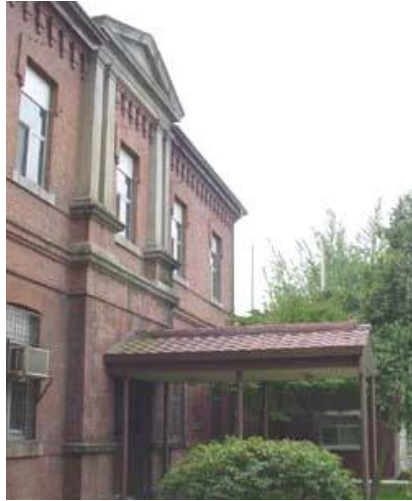
Figure 3.63. Building 2474 (IB-085) with tightly stacked redbrick layers

Examples of sturdy structures: Due to frequent earthquakes, Japanese architects have developed ways of building sturdy structures. Tightly stacked brick layers are good examples of sturdy structure.

Figure 3.63 illustrates artistic details expressed on the sturdy structure of building 2474 (IB-085).

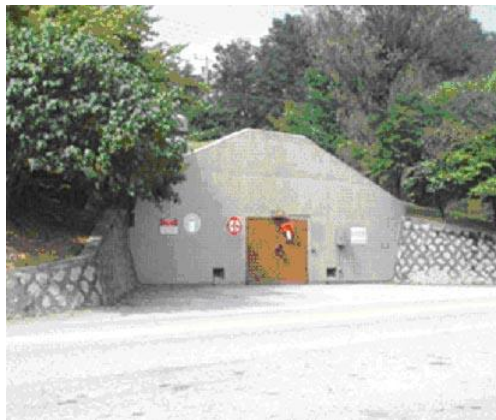
Figure 3.64. Japanese bunker (building 4926, IB-194) located in the South Post

Bunker: A bunker (building 4926, IB-194) was found in the South Post. Exact construction year of the bunker is unknown.

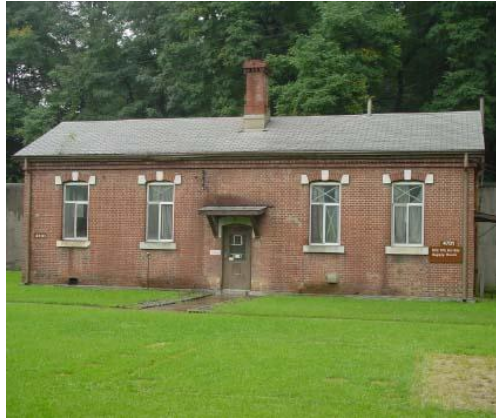
Figure 3.65. Japanese prison (building 4710, IB-194) built in 1909

Prison: Building 4710 (IB-117) is one of few buildings preserved in good shape. The building, built in 1909, is considered to be architecturally beautiful. Ironically, this building was previously used as prison, where many of Korean workers were imprisoned. The building has been maintained well with its original exterior. The inner wall was built flat to prevent escaping, while the exterior shows typical tight brick layers.

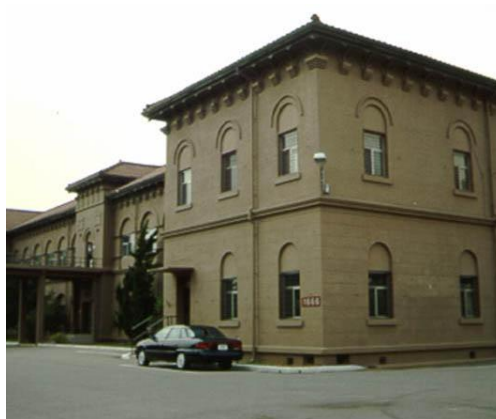
Figure 3.66. Japanese hospital (building 1666, IB-042)

Hospital: Building 1666 (IB-042) was used as a Japanese military hospital. During the truce meetings (1945-1948) between the U.S. and the Soviet Union, the Soviet Union dispatches stayed in this building.

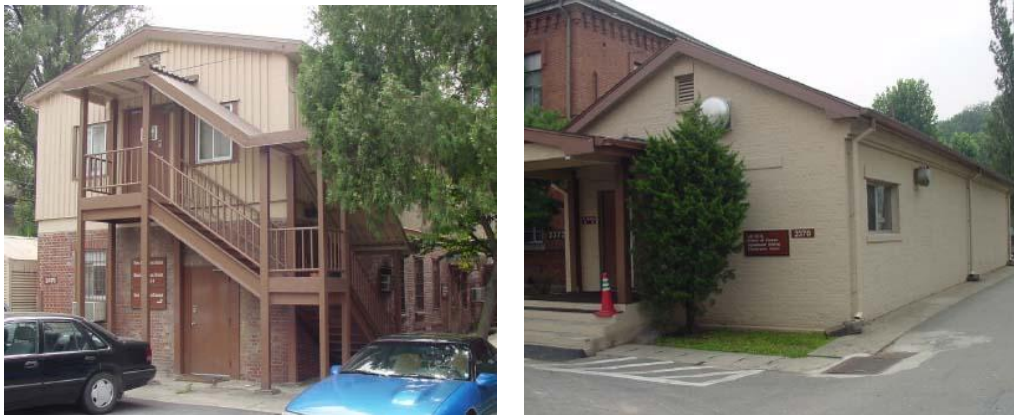
Figure 3.67. Expansion structures added to indigenous building 2476 (IB-082) and 2370 (IB-083)

As mentioned before, most of indigenous buildings went through modification and renovations. Besides interior renovations including windows, window frames and space zoning, exterior of the buildings has been changed through cement coating, insulation material application, etc.

As shown in figure 3.67, building 2476 (IB-082) is an indigenous building with a newly added structure on the top. Building 2370 (IB-083) is attached with a new expansion structure.

- No significant alteration of buildings is recommended.
- Controversial buildings need further inspection, particularly interior, by experts for the determination of year and identity.
- It is recommended that the garrison provide the inventory of indigenous buildings listed in this document when discussion on the relocation or closure of the garrison is initiated by the host-nation and USFK.

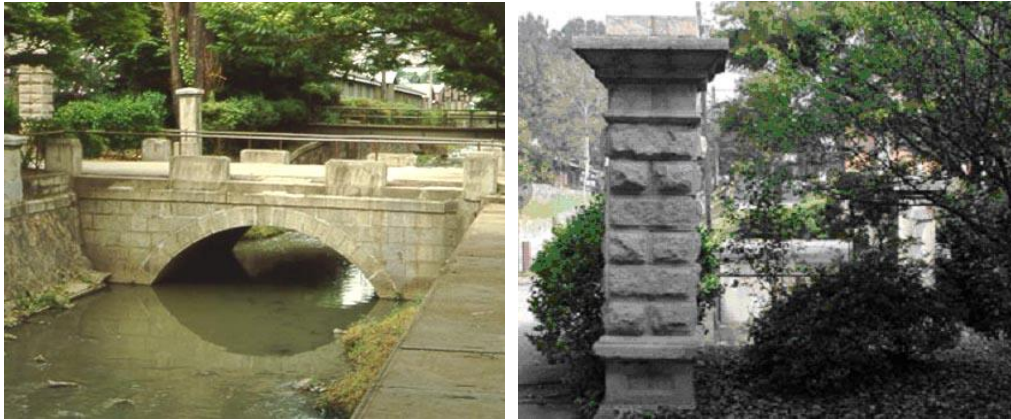
Figure 3.68. Bridge (ES-001) behind building 2310 (right) and jamb detail (right)

There are a bridge and bridge jambs to north of building 2310. The bridge and bridge jambs are beautifully constructed with stones (figure 3.68). There are nine piles at the end of the road, stretched from the bridge as shown in figure 3.69.

- It is recommended that these engineering structures be kept as they are.

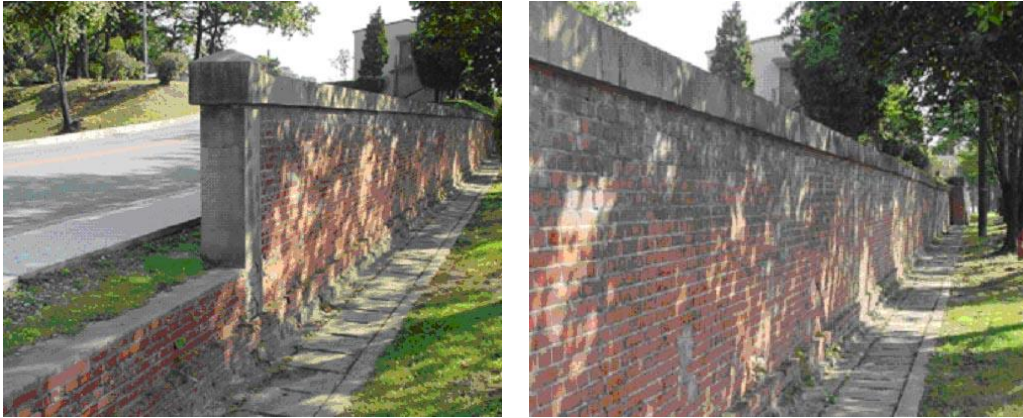
Figure 3.70. Brick wall (ES-002) that runs near building 1397 and 1398 (left) and building 1377 (right)

Japanese brick walls (ES-002 and ES-003) were identified in front of building 1397 and 1398; and building 1330 respectively (figure 3.70). Though additional height has been added to the wall (ES-003) near building 1330, the original shape is well preserved (figure 3.71).

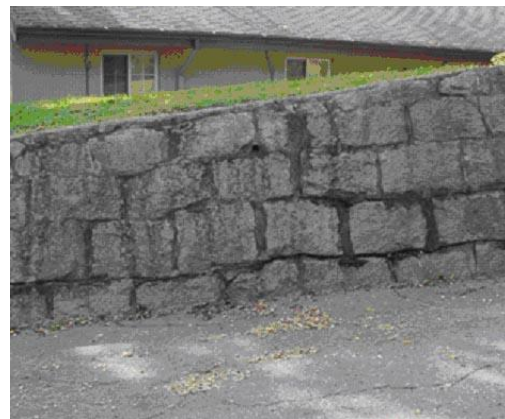
Figure 3.72. Japanese castle wall (ES-006) near building 2028

A trace of Japanese style castle wall (ES-006) was found near building 2028 (figure 3.72).

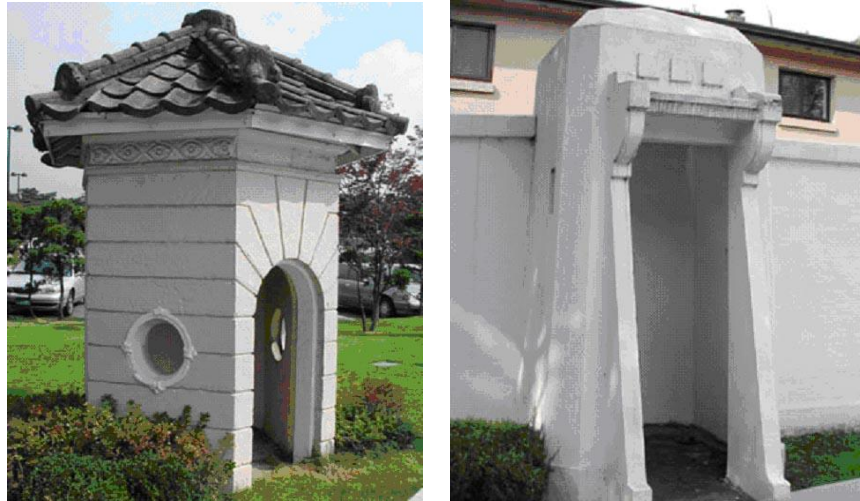
Figure 3.73. Japanese guard posts in Yongsan Garrison

Two Japanese guard posts were observed. One is located in the middle of the wall in front of building 2723 while the other is located in front of Dragon Hill Lodge. The guard post near Dragon Hill Lodge is similar to those guard posts located at the Japanese Chosun government headquarter.

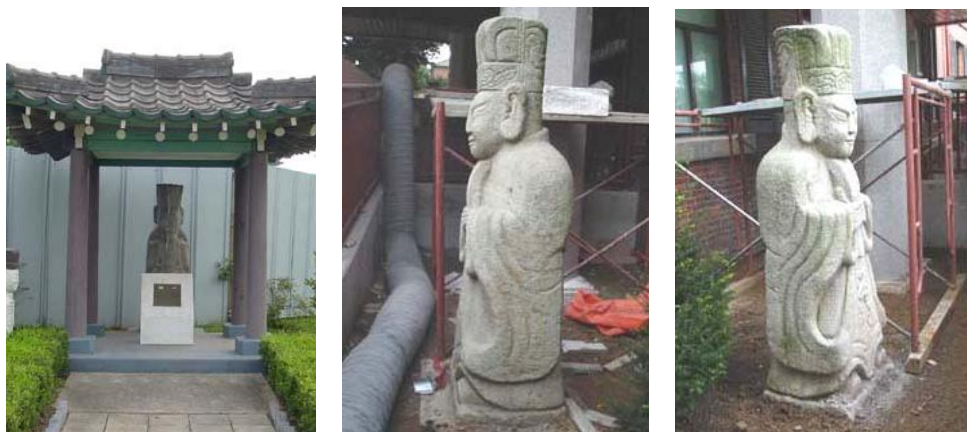
Figure 3.74. Stone guardians in good shape (S-001, S-007 and S-008)

Five stone guardians and three stone sculptures were found from scattered areas. Based on the magnitude of stone guardian S-007 and S-008, it is estimated that these stone figures originally belonged to the grave of a high-profile person of the early 18th century (figure 3.74). As seen in the figure 3.75 and 3.76, two stone guardians (S-002 and S-006) are damaged by paintings and erosion. All the stone sculptures (S-003, S-004 and S-005) are damaged by paintings. These stone figures seemed to be moved from their original locations to current locations.

- Paintings over the stone figures need to be removed using the methods and procedures in chapter 4 of this document.
- Stone guardians S-007 and S-008 should be moved to a safer place.

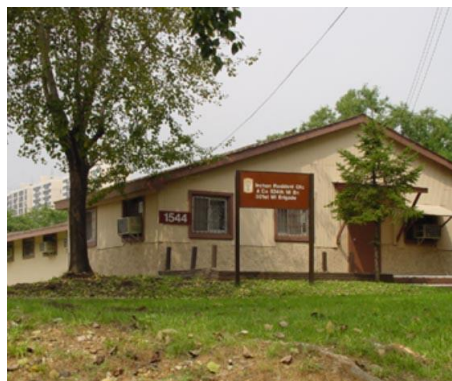
Figure 3.78. Building 1544 (IB-031) with cement mortar coatings over the wall

During the survey, only exterior of buildings was examined because access to the buildings was limited to surveyors. Most of buildings were renovated for different usages; however, building 1730 (IB-020) and 1769 (IB-027) were remaining intact in their original shape. Among the identified indigenous buildings, building 1544 (IB-031) would need more investigation to finalize the building's year and identity (figure 3.78).

- No further major alteration of the buildings is recommended.
- Maintenance or construction personnel who encounter any Japanese remains would need to immediately notify the ACoS, Engineer through the installation commander according to USFK-EGS Art. 12-3. Upon discovery of the remains, the personnel should stop the activity that might cause adverse effect on the remains until appropriate mitigation or transfer is completed.

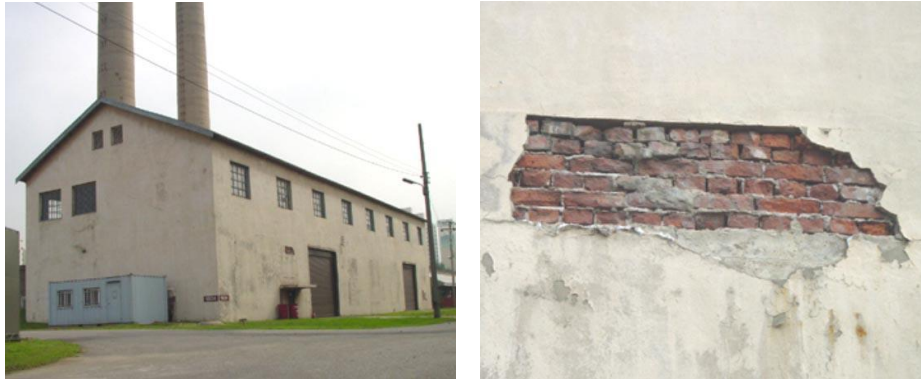
Figure 3.79. Building 1294 (IB-002) coated with cement mortar and original brick wall inside of the coating (left)

As described in table 3.16, most of buildings have lost their original shapes. Building 1924 (IB-002), shown in figure 3.79, was originally built with red bricks. However, cement mortar was coated over the original brick wall. Cement mortar coating is a common example of modification found from many indigenous buildings at Camp Market.

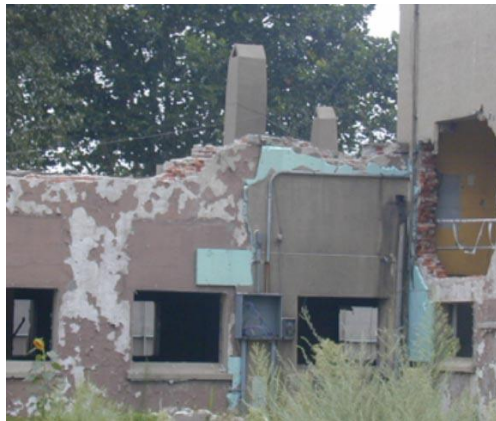
Figure 3.80. Partly demolished building 1776 (IB-030)

Building 1776 (IB-034) was being partly demolished on time of survey as shown in figure 3.80.

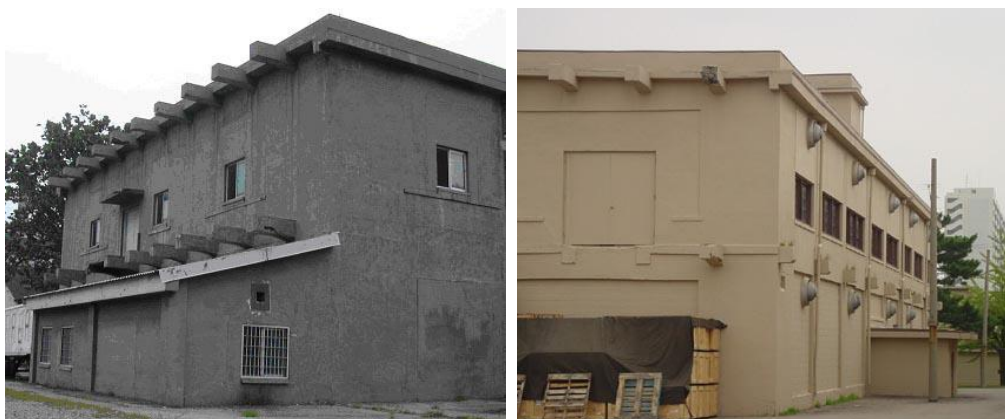
Figure 3.81. Modern style structures: building 1512 (IB-007) and 1520 (IB-012)

Most buildings in the northern part of the camp are large-sized modern style buildings. Building 1512 (IB-007) is made of reinforced concrete (figure 3.81). In some parts, reinforcing steel beams are exposed and corroded. Building 1514 (IB-011) and 1520 (IB-012) are typical modern style buildings.

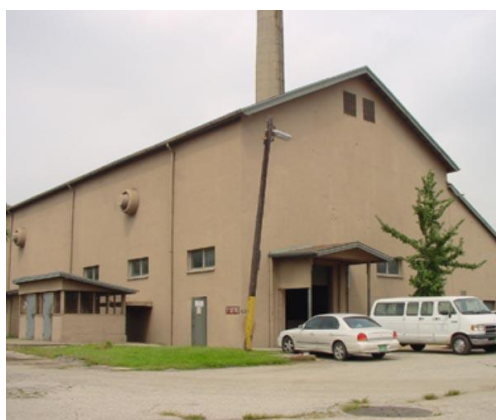
Figure 3.82. Building 1770 (IB-029) with a huge chimney

Building 1770 (IB-029) has a huge chimney as shown in figure 3.82. It is estimated that this building was used as an incineration building by Japanese troops.

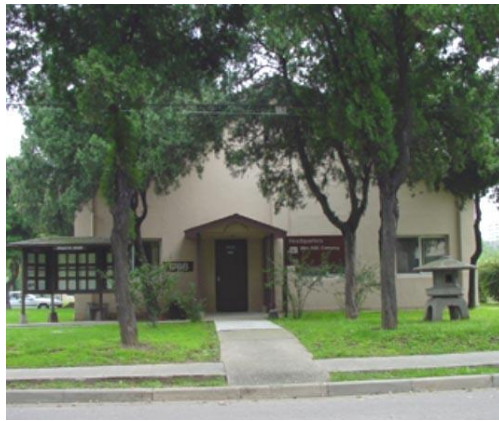
Figure 3.83. Building 1768 (IB-022) with a Japanese-style stone lantern

Building 1762 (IB-023), 1764 (IB-026), 1766 (IB-030) and 1768 (IB-022) are located adjacent to each other. Among these buildings, building 1768 is relatively well preserved (figure 3.83). A Japanese style stone lantern (S-001) is standing in front of the building (figure 3.84). It is estimated that the lantern was manufactured early in the 20th century.
